Field Remedy: 2469

Subject: **Glued driveshaft - Missing service instruction**

Models:	Engines:	Option:
Insignia 2008...,Astra-J 2010...	A20DT A20DTC A20DTH A20DTJ A20DTL,A13DTE A17DTJ A17DTR A20DTH	Only vehicles with front wheel drive.

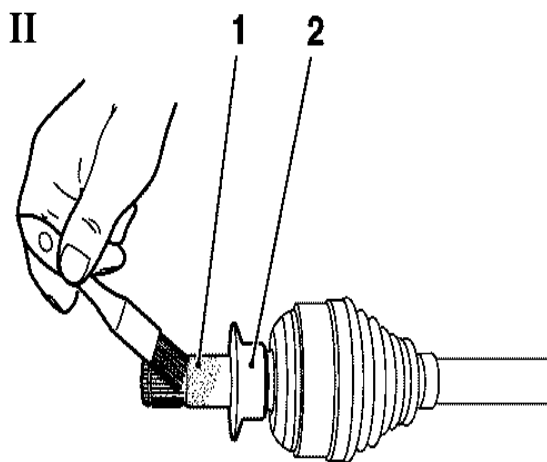
I

Complaint:	Drive shaft right side cannot be separated from intermediate shaft.
Cause:	Drive shaft right side is glued (Safety compound) with intermediate shaft.
Production:

Important:
Drive shaft right side cannot be separated from the intermediate shaft.

Note:
New drive shaft and new intermediate shaft will be supplied as single parts and have to be glued (Pic I, arrow) together (Safety compound).

In case of repair remove the right drive shaft together with the intermediate shaft.

- Clean intermediate shaft and stud of drive shaft
- Mount oil slinger on inner stud of drive shaft
- Coat inner drive shaft stud with Safety compound
- Mount bearing and flange on intermediate shaft
- Plug drive shaft and intermediate shaft together.

Duration of Safety compound curing amounts at 21°C approx. 12 hours. Safety compound curing before or after the installation, when curing after installation the vehicle may not be driven, but it can be completed and be pushed.
